Research Article

Comparison of the Ability of Two Brands of CBCT with That of SEM to Detect the Marginal Leakage of Class V Composite Resin Restorations

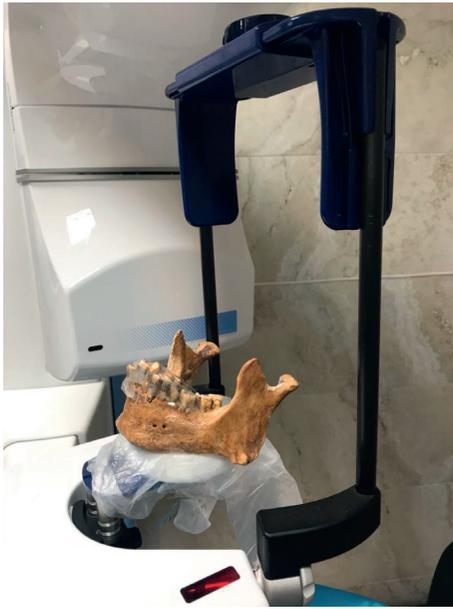
FIGURE 1: Teeth mounted on a dried mandible bone in the CBCT unit.

2.5. CBCT Imaging. The teeth were mounted in the sockets of a human mandible bone and observed by CBCT. CBCT images were taken by two units, including New Tom CBCT unit (New Tom GiANO; Quantitative Radiology, Verona, Italy) and Planmeca CBCT unit (Planmeca ProMax 3D Mid machine; Helsinki, Finland) (Figure 1). The adjusted scan parameters of the New Tom CBCT unit were 90 kV, 3 mA, and 9 seconds. The field of view (FOV) was 8 * 11 cm Hi-Res., and the voxel size was 75 μm. The adjusted scan parameters of the Planmeca CBCT unit were 90 kV, 12.5 mA, and 15 seconds. The FOV was 10 * 10 cm, and the voxel size was 150 μm. The projections were analyzed by NNT (New Tom software) and Planmeca Romexis software in the cross-sectional plane (slice thickness = 0.5 mm and slice distance = 0.1 mm) by two maxillofacial radiologists to detect marginal leakage along the gingival and coronal walls of class V cavities. The observers were blind to each other's responses. No software was used for artifact reduction.

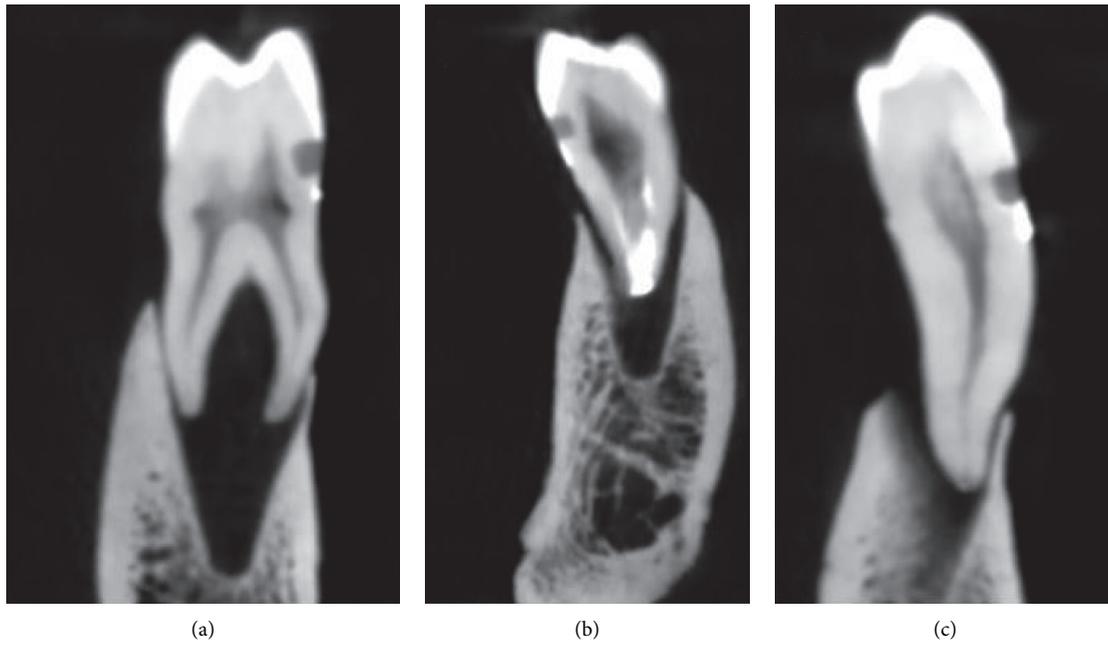
FIGURE 2: Marginal leakage on the gingival wall detected by the New Tom CBCT unit (New Tom GiANO; Quantitative Radiology, Verona, Italy). (a) Score 0. (b) Score 1. (c) Score 2.

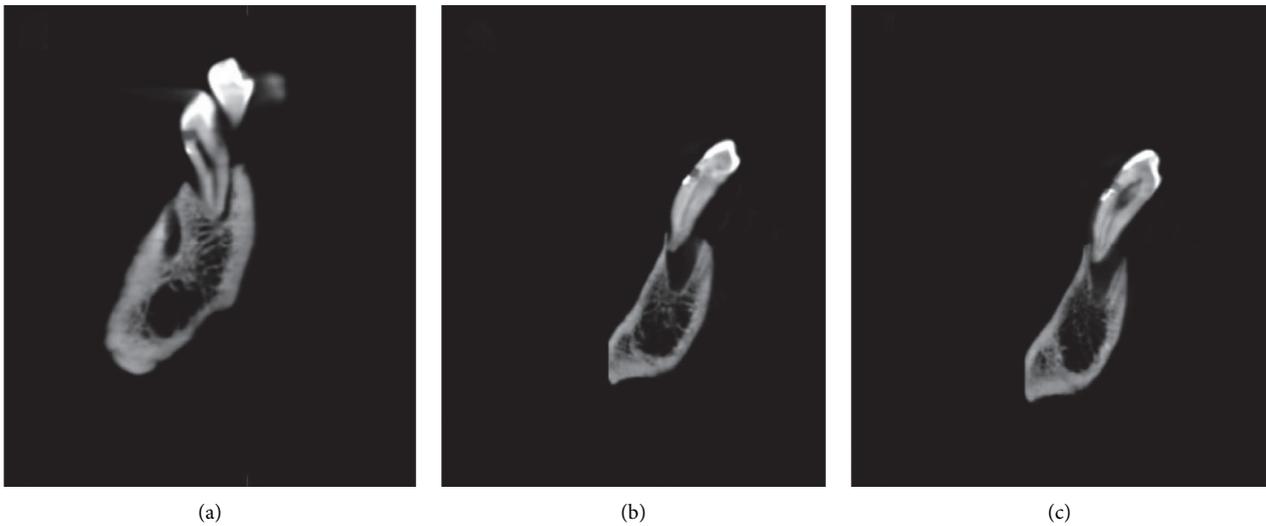
FIGURE 3: Marginal leakage on the gingival wall detected by the Planmeca CBCT unit (Planmeca ProMax 3D Mid machine, Helsinki, Finland). (a) Score 0. (b) Score 1. (c) Score 2.

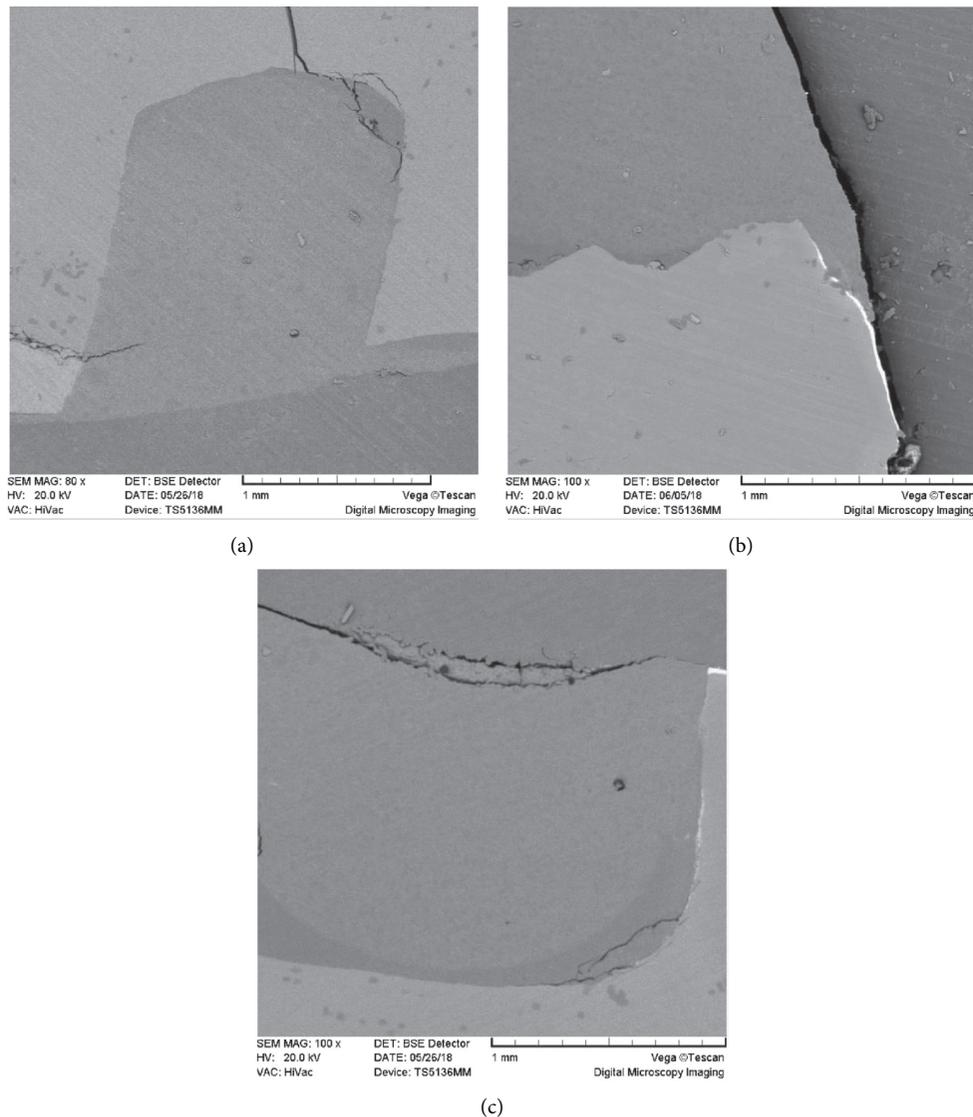
FIGURE 4: Marginal leakage on coronal and gingival walls detected by SEM (Cam-Scan MV2300; Slovakia). (a) Marginal leakage, score 0, on the coronal and gingival walls, 60x. (b) Marginal leakage, score 1, on the gingival wall, 100x. (c) Marginal leakage, score 2, on the gingival wall, 100x.

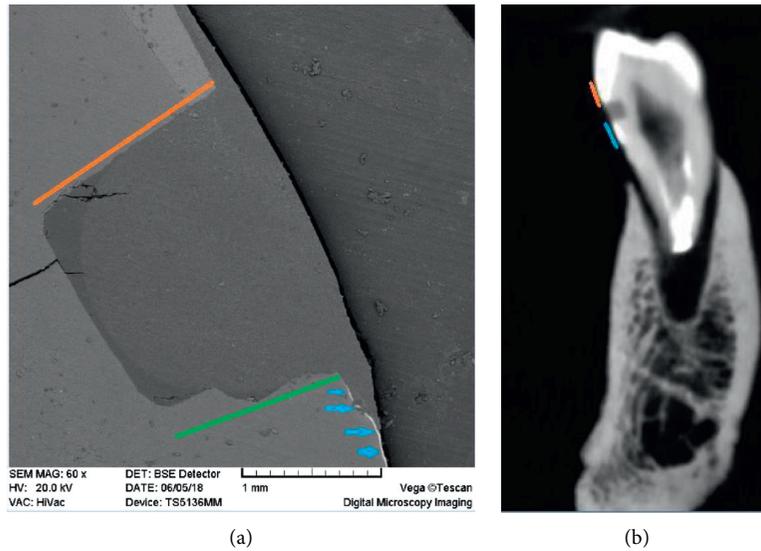
FIGURE 5: Silver nitrate leakage along gingival and coronal walls of a composite resin restoration. (a) Red line: coronal wall; green line: gingival wall; blue arrows: silver nitrate. (b) Red line: enamel radiopacity; blue line: silver nitrate radiopacity.

CBCT has limitations in assessing the marginal leakage of the coronal wall of class V cavities. As shown in Figure 5, SEM can reveal the marginal leakage of the coronal walls as

well as the gingival walls of class V composite resin restorations. However, this might not be always true for the CBCT because some parts of the coronal wall of class V cavities are located in the enamel, and the radiopacity of enamel obscures the radiopacity of silver nitrate tracer. As a result, the CBCT observer may underestimate the amount of leakage on the coronal wall. However, when the leakage extends to the dentin beyond the enamel, it is definitely recognizable on the CBCT images. This can be considered one of the limitations of CBCT against SEM in the detection of marginal leakage.

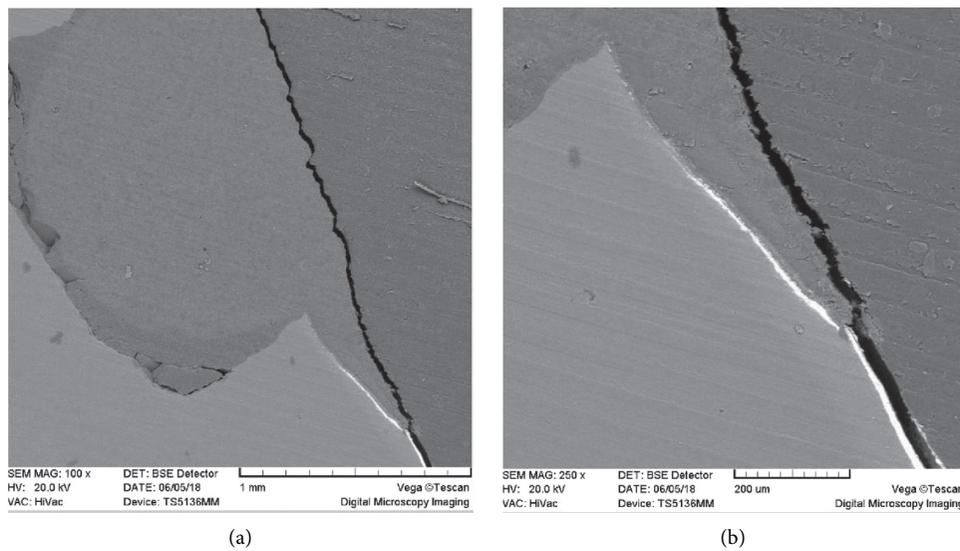
FIGURE 6: Marginal leakage of the gingival wall at different SEM magnifications. (a) 100x magnification. (b) 250x magnification.

assess the leakage through SEM images. The entire tooth-restoration interface was quite visible at 80x magnification, and as the SEM magnification was increased above 80x, more details became visible and the silver nitrate tracing became more accurate (Figure 6). However, increasing the magnification of CBCT images degrades the ability to evaluate the details due to the loss of image clarity. This can be taken into account as another limitation of CBCT in the detection of leakage.
